THE HUBBLE SPACE TELESCOPE SERVICING MISSION 3A CONTAMINATION CONTROL PROGRAM

Patricia A. Hansen

NASA/Goddard Space Flight Center, Greenbelt, Maryland 20771

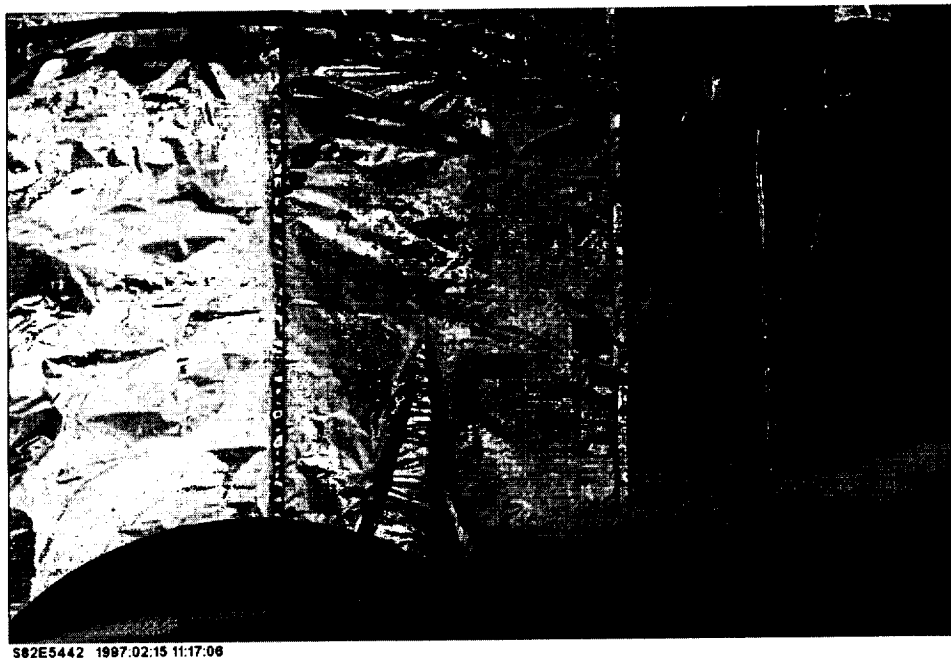
Fig. 2: SM2 FEP/VDA Specimen on-orbit

The top-center of this image shows the roughly triangular SM2 LS specimen on the Light Shield at SM2 prior to retrieval. A handrail and standoffs are apparent across the top of the image. The specimen is curled very tightly, so that it is detectable here as a triangular region where the next layer of the MLI is visible. The raised feature at the bottom edge of the triangular opening contains the entire specimen that covered this triangle prior to the damage. At the bottom of the image, the tip of the largest crack on HST is seen propagating vertically towards the top of the telescope. This large crack also opened to reveal the next MLI layer.

upper part of the Light Shield (Figs. 2-3). However, on closer examination of the telescope, significant damage was observed on most MLI blankets [Zuby 95, Town 99, Hans 98].

Results from the SM2 sample indicated that the material's mechanical properties had been greatly compromised and would, therefore, not withstand excessive handling during future servicing missions. The number and length of cracks in the MLI blanket's outer layer had increased dramatically between SM1 and SM2. Predictions of the MLI damage for future missions, based on these observations were very conservative.
